INSPECTION REPORT

Date - October 5th 2011
Input - On-site accident investigation
Reference - RGA2400215 (Euromekanik AB)
Created by - Vaclav Potucek – Clean Energy & Claim solutions
Approved by - Libor Mikulka – Plant Manager
Jiri Storch – Quality & Production manager

Model number
CT1000SS

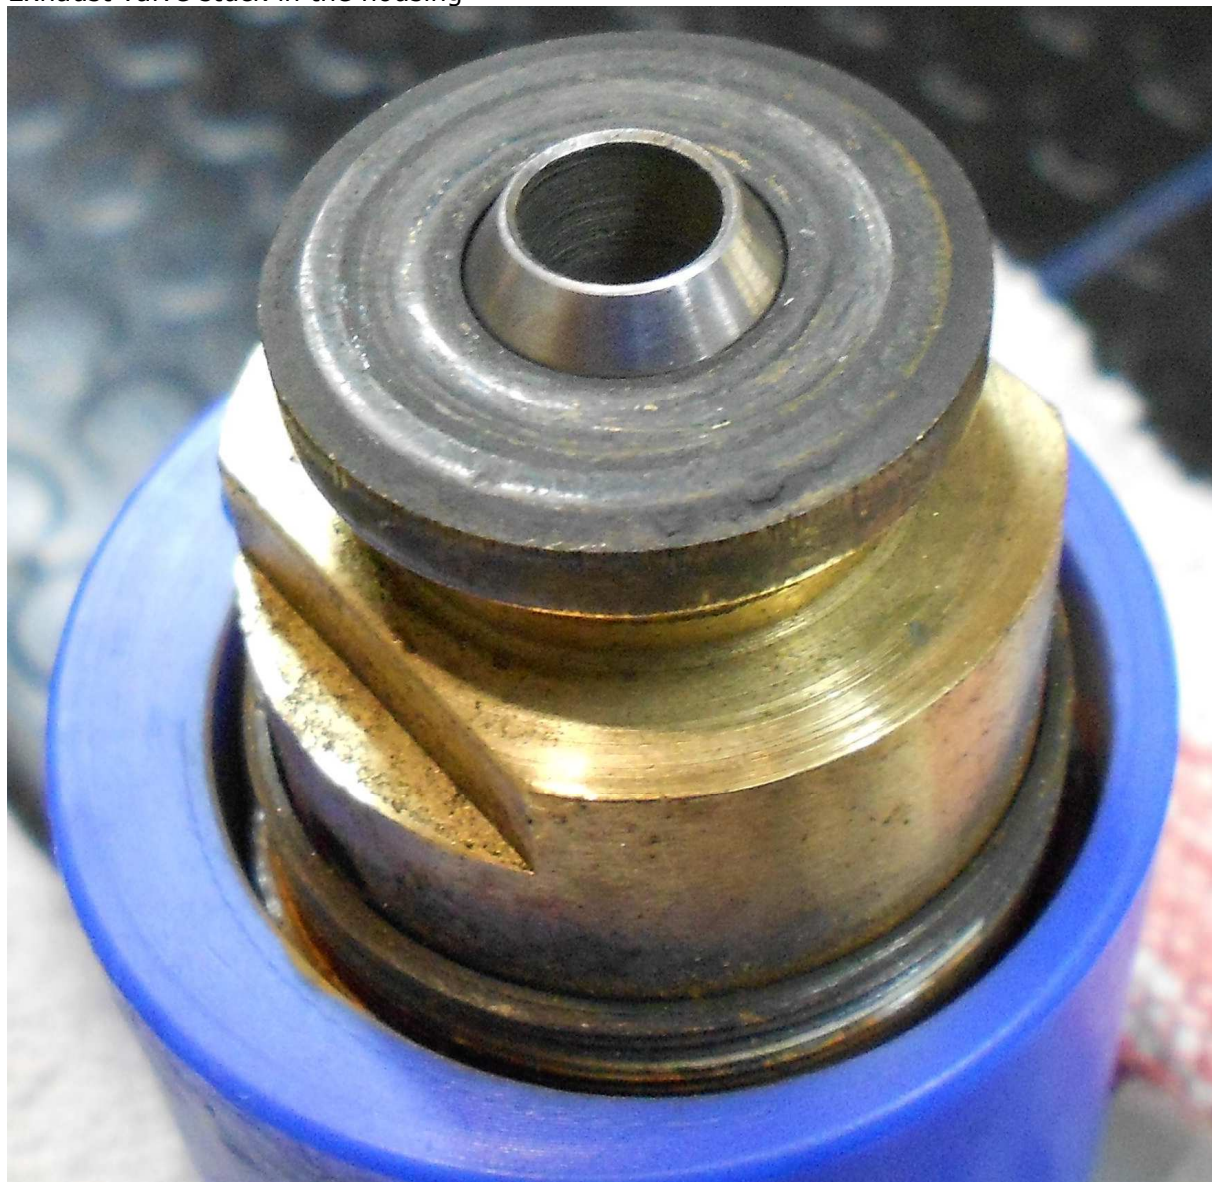
After removing the jaws, exhaust valve housing was visually inspected. Signs of wear were obvious. Exhaust valve was stuck in the housing.

Exhaust valve stuck in the housing

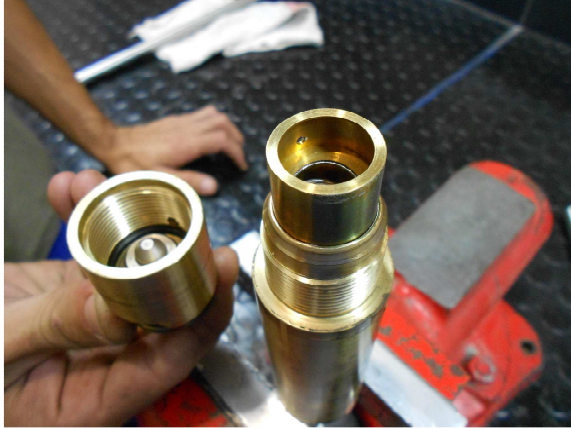
Exhaust valve housing was removed and internal parts were inspected. Seal tensioner was not damaged. Springs under the Seal tensioner were in place and also without damage.

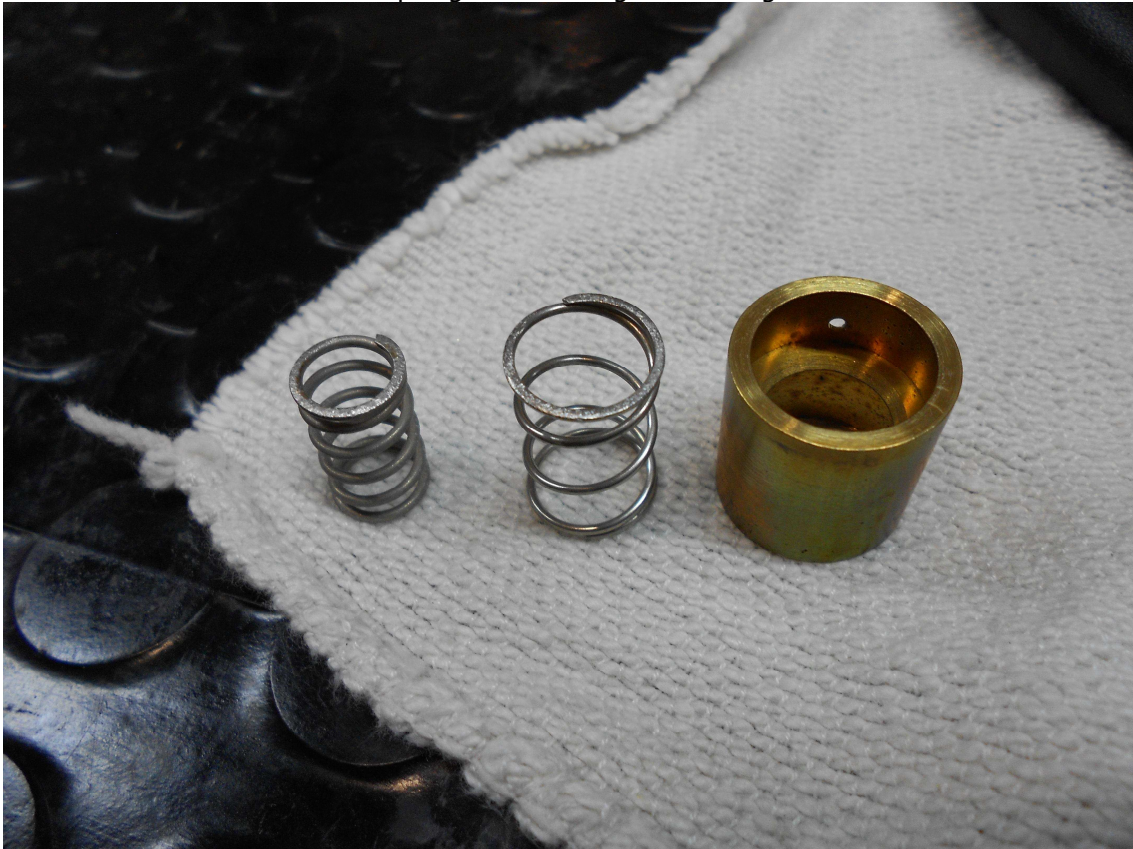
Removed seal tensioner and springs with no sign of damage

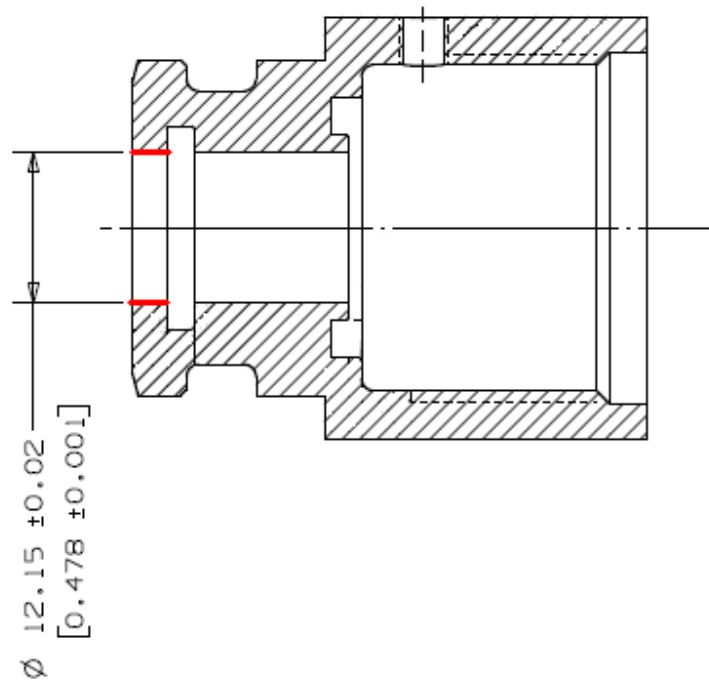
Measurements of exhaust valve housing showed that the inside diameter of the valve hole was undersized by 0.23mm (measured 11.90mm).

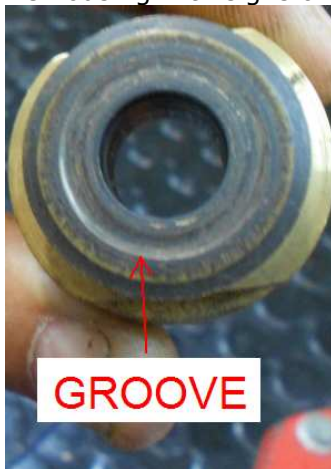
We found an artificial groove on the housing surface. This groove was created by interference between housing and receptacles during filling processes. The depth of the groove was not consistent as shown on below image.

Valve housing with signs of wear

Exhaust valve housing was undersized on the very top, causing it to squeeze the valve into the point of completely blocking it. This undersized condition was caused by car receptacles pushing onto exhaust valve housings.

Routine maintenance mentioned in Installation instructions delivered with every nozzle must be followed. OPW shall update them to make the jaws inspection clear and implemented as a part of every routine check. Routine check should be done at least once a month.

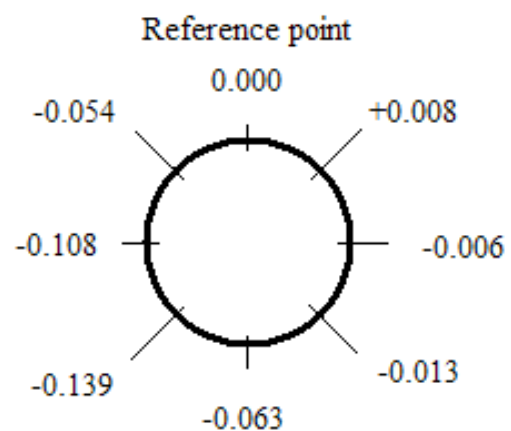
Measurements of differences in depth of groove

Receptacle shall not push onto housing so rapidly and so intensively. Difference within the depth of groove was caused by the receptacle pushing mainly from on side, which indicates lack of tension between receptacle and jaws. Possible cause of this condition is that jaws were worn and connection between receptacle and nozzle was not secure.
